**Flood Control Project Maintenance  
Levee Inspections****LMA District Cover Sheet****Spring 2014 Levee Inspection Results****Reclamation District No. 0349 Sutter Island**

**Spring 2014 Levee Inspection Results**

**Reclamation District No. 0349 Sutter Island**

**Levee Inspection Report By Mile - Spring 2014**

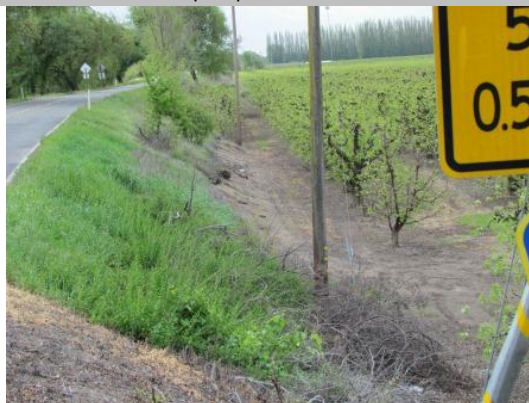
Photo 1 of 1 : phillips\_s\_20140407\_626.JPG

Looking downstream from levee mile 0.00 landside slope and toe.  
Photo taken 03-27-2014.

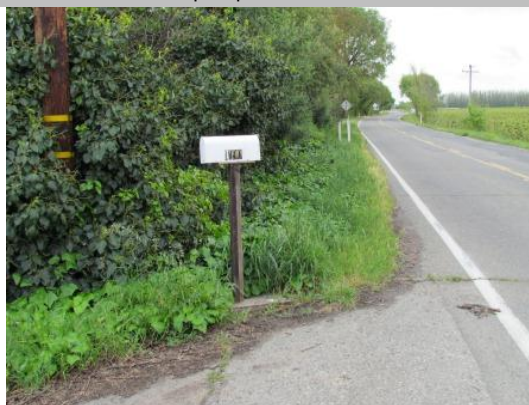
Photo 1 of 1 : phillips\_s\_20140407\_627.JPG

LM Start	0.00	Rating **	U	Issue No.	5
LM End	0.00	Issue Type +	Ma	Location *	WS
Category	Earthen Levee			GPS Latitude/Longitude	
				Start	End
Item	Trim / Thin Trees			38.327004 °	38.327009 °
				-121.577011 °	-121.577013 °
DWR ID	DWR_RD0349_01_s_2012_5				
Action/Comments					
Thin trees to allow visibility of the ground and room to flood fight. Inspector Comments: There are trees at this location that can be trimmed up to see the ground.

Looking downstream from levee mile 0.00 unsatisfactory woody tree growth on waterside. Photo taken 3-27-2014.

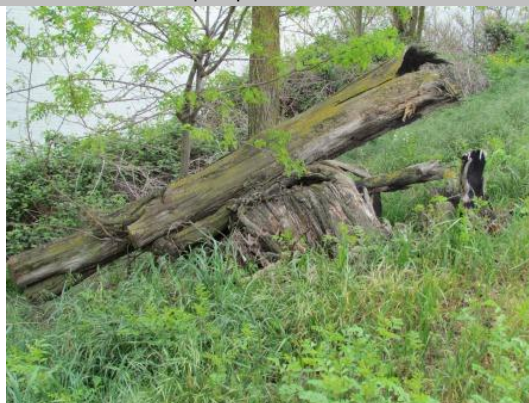
Photo 1 of 1 : phillips\_s\_20140407\_630.JPG

Unsatisfactory dead tree on waterside slope. Photo taken 03-27-2014.

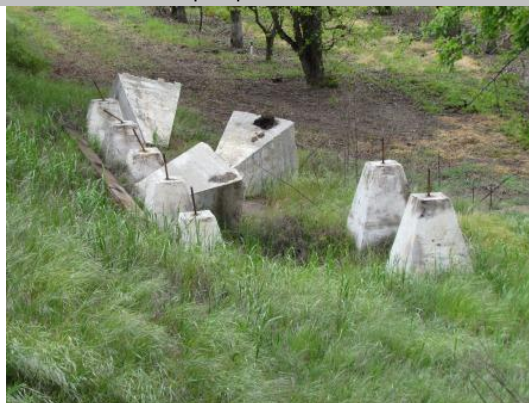
Photo 1 of 1 : phillips\_s\_20140407\_628.JPG

Unsatisfactory pile of concrete foundation blocks on levee toe. Photo taken 3-27-2014.

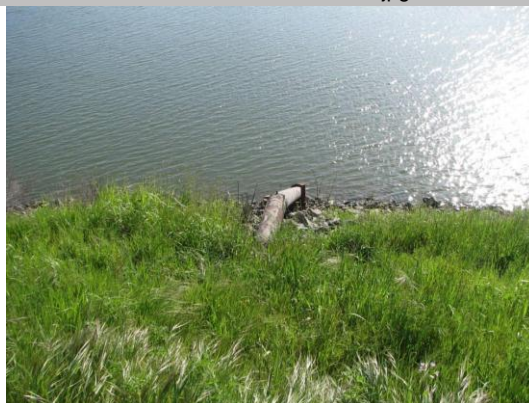
Photo 1 of 1 : UCIP\_2515.jpg

LM Start	0.47	Rating **	M	Issue No.	20
LM End	0.47	Issue Type +	En	Location *	LS
Category	Supplemental			GPS Latitude/Longitude	
				Start	End
Item	DWR UCIP Field Study			38.320476 °	38.320476 °
				-121.578616 °	-121.578616 °
DWR ID	DWR_RD0349_01_s _ 2014_20				
Action/Comments					
Inspector Comments: FS_ID:21564					
EP_NO: N/A					
Repair Type:					
Crossing Status:					
UCIP Comments: Exposed section of levee lope on landward side--need to contact owner and DWR inspector. Burrow activity noticed at crossing 10 inch holes. Dense vegetation limits the inspector's visibility to identify signs of pipe failure (leaks) along the slope. Recommend removing vegetation along pipe alignment to conduct proper inspection of structure and appurtenances. Note date on photos should be 3/18/09 not 7/26/08 camera metadata is incorrect.					
FIELD_STRUCT_DESC: 8-inch steel pipe measured (instead of 10-inch) sleeved through a 12-inch steel pipe, 6.6 feet below the crown. Annular gap grouted at both ends. Active centrifugal pump on platform at landward toe. Inactive slant pump on steel platform on waterward slope. Exposed section pipe on waterward slope. Service pole on the landward slope. (USACE-1959). This entry matches the Drainage or Irrigation Structure referenced in O&M manual (HLM 0.5). Pipe sleeved through pre-existing pipe under Permit No. 3382 (1960).

View of pipe on waterward side with rip rap on toe--dense vegetation on slope.

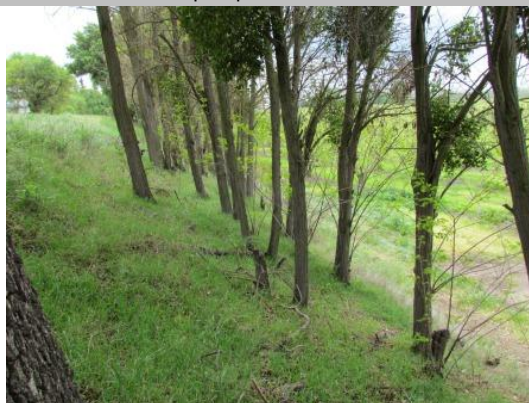
Photo 1 of 1 : phillips\_s\_20140407\_625.JPG

Unsatisfactory woody growth on landside slope and toe. Photo taken 3-27-2014.

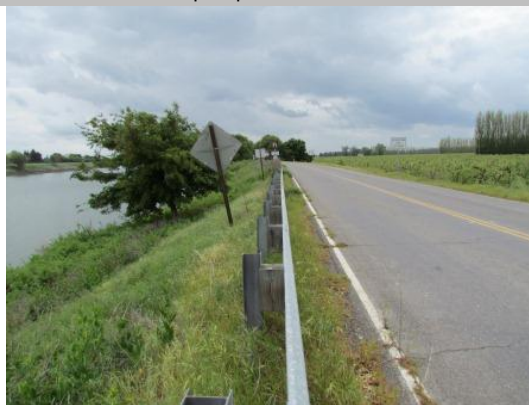
Photo 1 of 1 : phillips\_s\_20140407\_629.JPG

LM Start	0.61	Rating **	U	Issue No.	28
LM End	0.72	Issue Type +	Ma	Location *	WS
Category	Earthen Levee			GPS Latitude/Longitude	
				Start	End
Item	Vegetation			38.318472 °	38.316881 °
				-121.579021 °	-121.579162 °
DWR ID	DWR_RD0349_01_s _ 2014_28				
Action/Comments					
Remove the wild growth other than native grasses from the levee slopes.

Wild growth on water side slope and toe, looking downstream. Photo taken 3-27-2014.

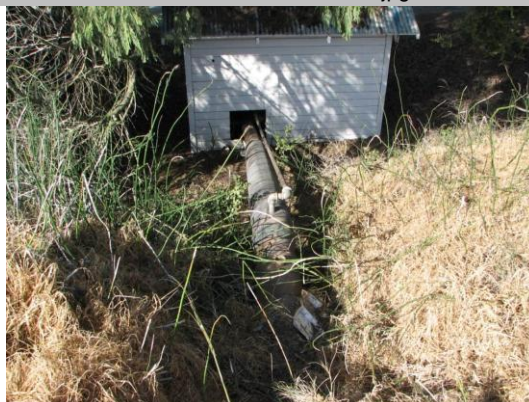
Photo 1 of 1 : UCIP\_2519.jpg

LM Start	1.03	Rating **	M	Issue No.	23
LM End	1.03	Issue Type +	En	Location *	LS
Category	Supplemental			GPS Latitude/Longitude	
				Start	End
Item	DWR UCIP Field Study			38.312496 °	38.312496 °
				-121.578625 °	-121.578625 °
DWR ID	DWR_RD0349_01_s_2014_23				
Action/Comments					
Inspector Comments: FS_ID:21566					
EP_NO: N/A					
Repair Type:					
Crossing Status:					
UCIP Comments: Exposed section of levee lope on landward side--need to contact owner and DWR inspector. Dense vegetation limits the inspector's visibility to identify signs of pipe failure (leaks) along the slope. Recommend removing vegetation along pipe alignment to conduct proper inspection of structure and appurtenances. Note date on photos should be 3/18/09 not 7/26/08 camera metadata is incorrect. FIELD_STRUCT_DESC: 14-inch pipe (waterward shoulder) and 12-inch pipe (landward shoulder) through the levee, 4.7 feet below the crown. Gate valve on the waterward slope. Pump in pumphouse on landward slope. Pressure breaker behind pumphouse. Pipe exposed on waterward slope. (USACE-1959). This entry matches the Drainage or Irrigation Structure referenced in O&M manual (HLM 1.1).

View of landward slope--open cut.

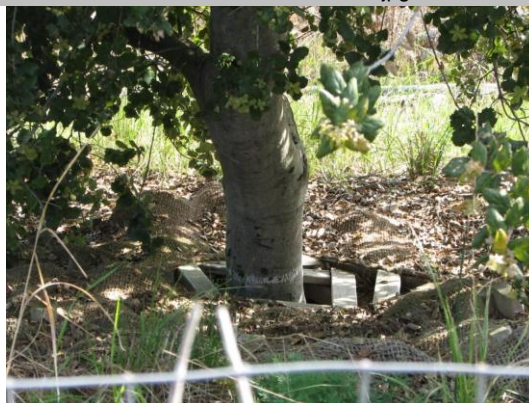
Photo 1 of 1 : UCIP\_2534.jpg

LM Start	1.19	Rating **	M	Issue No.	24
LM End	1.19	Issue Type +	En	Location *	LS
Category	Supplemental			GPS Latitude/Longitude	
				Start	End
Item	DWR UCIP Field Study			38.310287 °	38.310287 °
				-121.577669 °	-121.577669 °
DWR ID	DWR_RD0349_01_s_2014_24				
Action/Comments					
Inspector Comments: FS_ID:21573					
EP_NO: N/A					
Repair Type:					
Crossing Status:					
UCIP Comments: 2007 DWR erosion repair site location?--need to find out fate of crossing. Dense vegetation limits the inspector's visibility to identify signs of pipe failure (leaks) along the slope. Recommend removing vegetation along pipe alignment to conduct proper inspection of structure and appurtenances. Note date on photos should be 3/18/09 not 7/26/08 camera metadata is incorrect.					
FIELD_STRUCT_DESC: Old pumphouse at landward toe. Pressure breaker on landward side. Check for pipes extending through levee from pumphouse. Add field description of crossing, if present.

Geotech fabric and protective frame at tree--design features of erosion repair site 2007-2009.

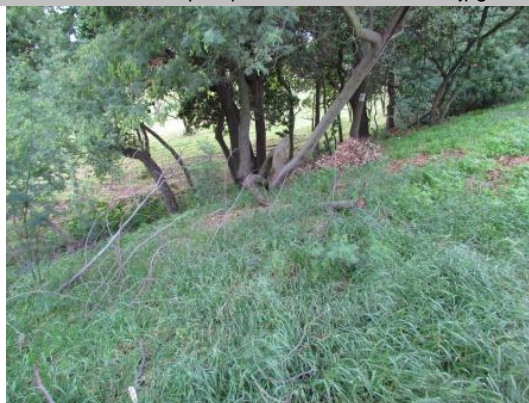
Photo 1 of 1 : phillips\_s\_20140520\_05896.jpg

LM Start	1.22	Rating **	M	Issue No.	34
LM End	1.22	Issue Type +	Ma	Location *	LS
Category	Earthen Levee			GPS Latitude/Longitude	
				Start	End
Item	Trim / Thin Trees			38.309858 °	38.309858 °
				-121.577433 °	-121.577430 °
DWR ID	DWR_RD0349_01_s_2014_34				
Action/Comments					
Thin trees to allow visibility of the ground and room to flood fight.

Trees need to be trimmed up and thinned out to see slope.

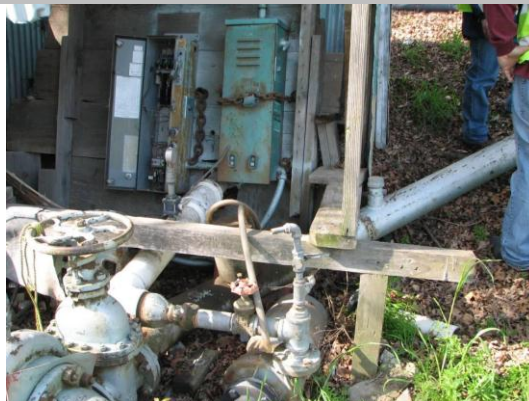
Photo 1 of 1 : UCIP\_2537.jpg

LM Start	1.36	Rating **	M	Issue No.	25
LM End	1.36	Issue Type +	En	Location *	LS
Category	Supplemental			GPS Latitude/Longitude	
				Start	End
Item	DWR UCIP Field Study			38.308143 °	38.308143 °
				-121.576215 °	-121.576215 °
DWR ID	DWR_RD0349_01_s _ 2014_25				
Action/Comments					
Inspector Comments: FS_ID:21574					
EP_NO: 18262					
Repair Type:					
Crossing Status:					
UCIP Comments: 2007 DWR erosion repair site location?--need to contact owner to determine if crossing is still in use. Dense vegetation limits the inspector's visibility to identify signs of pipe failure (leaks) along the slope. Recommend removing vegetation along pipe alignment to conduct proper inspection of structure and appurtenances. Note date on photos should be 3/18/09 not 7/26/08 camera metadata is incorrect. FIELD_STRUCT_DESC: 7-inch pipe sleeved through a 10-inch pipe through the levee, 3.2 feet below the crown. Steel cutoff wall around pipe at center of levee. Siphon breakers at shoulder. Sump at landside toe. Pump and gate valve in pumphouse and anchor block on the waterward slope. (Permit No. 18262-2007)

Damage shed houses crossing appurtenances such as control panel, power source, piping and valves.

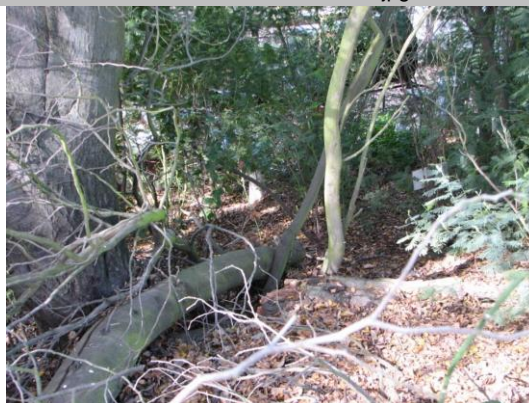
Photo 1 of 1 : UCIP\_2526.jpg

UCIP Comments: 2007 Erosion Repair Site location?--Need to contact owner to determine if crossing is still in use. Dense vegetation limits the inspector's visibility to identify signs of pipe failure (leaks) along the slope. Recommend removing vegetation along pipe alignment to conduct proper inspection of structure and appurtenances. Note date on photos should be 3/18/09 not 7/26/08 camera metadata is incorrect. FIELD\_STRUCT\_DESC: 6-inch steel irrigation pipe, 4.0 feet below the crown. Siphon breaker and protective housing at levee shoulder. Pump on waterward side. Pipe exposed on waterward slope, extending to pump. Discharge structure at landward toe. (Permit No. 12005-1977) FS Date: 3/18/2009

View of landward side.

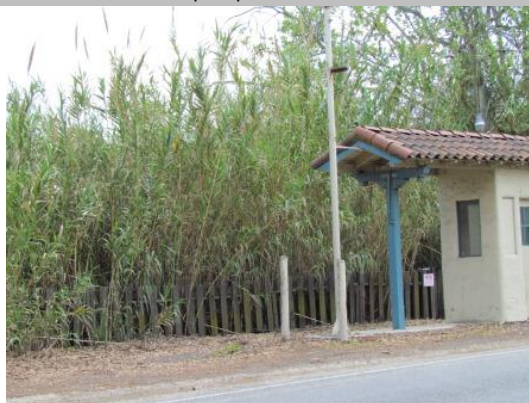
Photo 1 of 1 : phillips\_s\_20140407\_631.JPG

LM Start	1.49	Rating **	U	Issue No.	12
LM End	1.59	Issue Type +	Ma	Location *	WS
Category	Earthen Levee			GPS Latitude/Longitude	
				Start	End
Item	Vegetation			38.306225 °	38.305122 °
				-121.574983 °	-121.574707 °
DWR ID	DWR_RD0349_01_f _ 2012_12				
Action/Comments

Unsatisfactory growth of bamboo on waterside slope and shoulder.

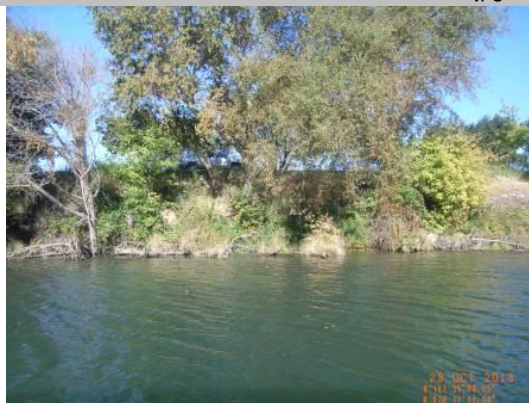
Photo 1 of 1 : USACE2013A\_STM\_24-7\_R\_2.jpg

Inspector Comments: 1997 - Erosion of very sandy levee behind large stand of riparian vegetation on top right bank. Dry ravel of sand. 1999 - Quarry waste rock was dumped down the levee slope; poor repair job; still eroding in places. Eroding at midslope off fabric. 2005 - Length revised, only the middle 150 - 200 ft are eroding. 2006 - Some rock/small material dumped down the bank but it is slowly unraveling. Upstream end is unraveling faster. Steep slope with poor gradation so fines are washing out. 2010 - Lots of overhanging trees and erosion pockets. 2011 - This site is upgraded to CRITICAL. Near vertical bank at the downstream end. New erosion at various locations throughout the site. 2013: No observed changes. [2013 Site ID: STM\_24-7\_R]

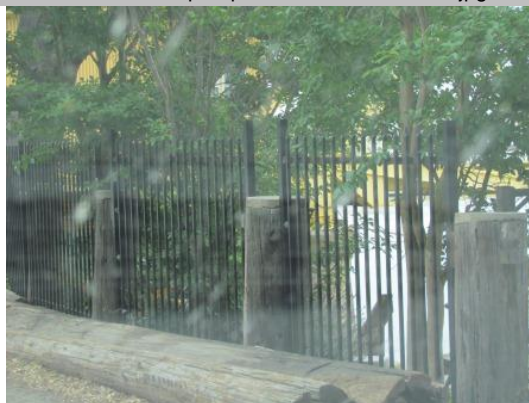
Photo 2 of 2 : phillips\_s\_20140520\_05900.jpg

Unauthorized fence adjacent to building waterside Sutter Slough.

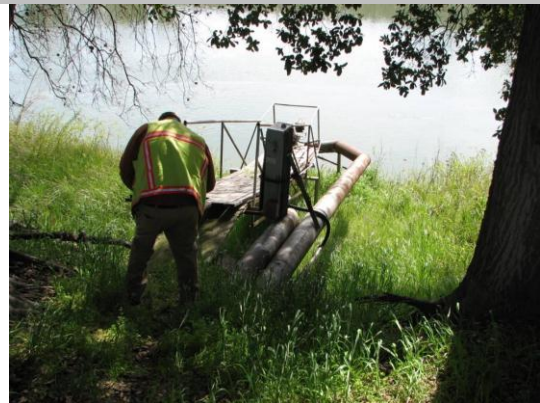
Photo 1 of 1 : UCIP\_2548.jpg

LM Start	0.10	Rating **	M	Issue No.	32
LM End	0.10	Issue Type +	En	Location *	LS
Category	Supplemental			GPS Latitude/Longitude	
				Start	End
Item	DWR UCIP Field Study			38.304606 °	38.304606 °
				-121.576323 °	-121.576323 °
DWR ID	DWR_RD0349_02_s_2014_32				
Action/Comments					
Inspector Comments: FS_ID:21577					
EP_NO: 2480					
Repair Type:					
Crossing Status:					
UCIP Comments: Dense vegetation limits the inspector's visibility to identify signs of pipe failure (leaks) along the landward slope. Recommend removing vegetation along pipe alignment to conduct proper inspection of structure and appurtenances. Unable to determine if crossing is in use. Note date on photos should be 3/18/09 not 7/26/08 camera metadata is incorrect.					
FIELD_STRUCT_DESC: 10-inch steel pipe through the levee, 6.0 feet below the crown. Pump and slide gate on the waterward slope. Concrete pipe riser and distribution box with gate valve at the landward toe. Service pole and anchor on the landward slope. (Permit No. 2480-1959)

Dense vegetation on waterward slope-2 pipes and 1 conduit.

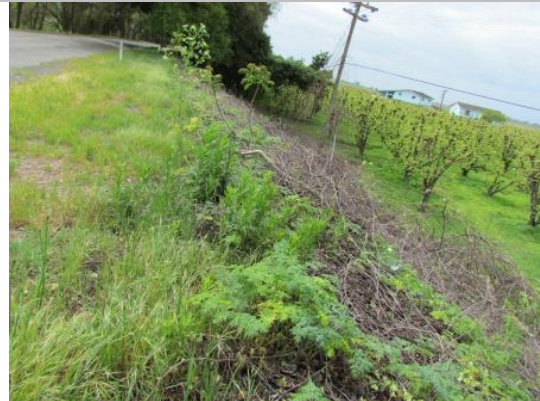
Photo 1 of 1 : phillips\_s\_20140520\_05907.jpg

Unwanted wild grapes growing on levee shoulder and slope blocking view of levee section.

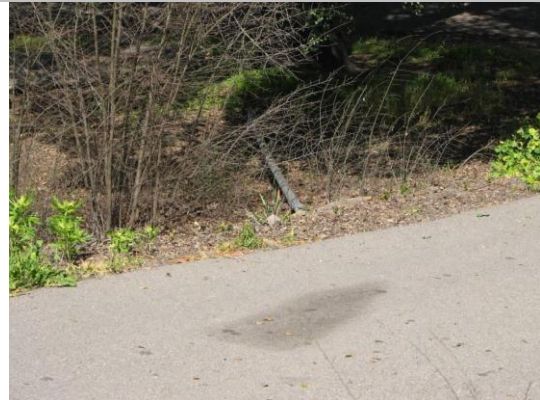
Photo 1 of 1 : UCIP\_2610.jpg

LM Start	0.13	Rating **	M	Issue No.	46
LM End	0.13	Issue Type +	En	Location *	LS
Category	Supplemental			GPS Latitude/Longitude	
				Start	End
Item	DWR UCIP Field Study			38.304345 °	38.304345 °
				-121.576824 °	-121.576824 °
DWR ID	DWR_RD0349_02_s _ 2014_46				
Action/Comments					
Inspector Comments: FS_ID:21613					
EP_NO: N/A					
Repair Type:					
Crossing Status:					
UCIP Comments: Dense vegetation limits the inspector's visibility to identify signs of pipe failure (leaks) along the slope. Recommend removing vegetation along pipe alignment to conduct proper inspection of structure and appurtenances. Note date on photos should be 3/18/09 not 7/26/08 camera metadata is incorrect.					
FIELD_STRUCT_DESC: 3-inch pipe through the levee, 3.3 feet below the crown. Gate valve on landward side. (USACE-1959). This entry matches the Drainage or Irrigation Structure referenced in O&M manual (HLM 0.1).

View of crossing on landward side.

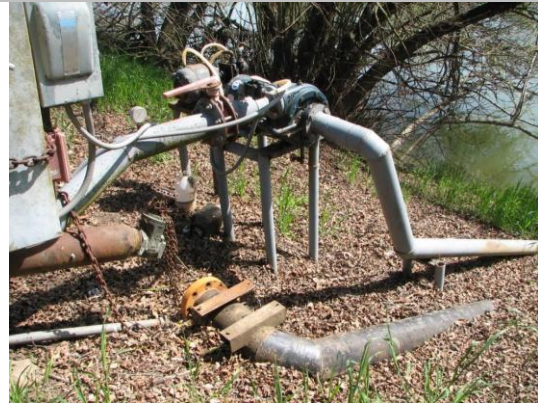
Photo 1 of 1 : UCIP\_2612.jpg

LM Start	0.28	Rating **	M	Issue No.	48
LM End	0.28	Issue Type +	En	Location *	LS
Category	Supplemental			GPS Latitude/Longitude	
				Start	End
Item	DWR UCIP Field Study			38.303072 °	38.303072 °
				-121.579066 °	-121.579066 °
DWR ID	DWR_RD0349_02_s_2014_48				
Action/Comments					
Inspector Comments: FS_ID:21614					
EP_NO: 12006					
Repair Type:					
Crossing Status:					
UCIP Comments: Altered crossing--contact owner to obtain new permit authoring work. Debris remains on site. Dense vegetation limits the inspector's visibility to identify signs of pipe failure (leaks) along the slope. Recommend removing vegetation along pipe alignment to conduct proper inspection of structure and appurtenances. Note date on photos should be 3/18/09 not 7/26/08 camera metadata is incorrect. FIELD_STRUCT_DESC: 6-inch steel irrigation pipe through the levee, 4.0 feet below the crown. 3-inch conduit through levee to service pump. Steel cutoff wall around pipe at center of levee. Siphon breaker in concrete riser at landward shoulder. Gate valve on landward side. Pump on concrete pad on waterward slope. Discharge structure at landward toe. (Permit No. 12006-1977)

New configuration--sections of pipe have been abandoned.

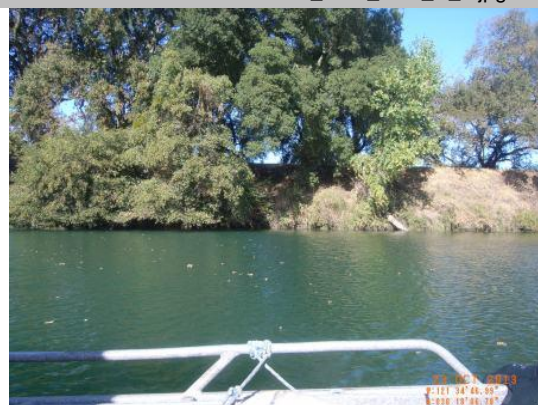
Photo 1 of 1 : USACE2013A\_STM\_25-8\_R\_2.jpg

LM Start	0.29	Rating **	M	Issue No.	28
LM End	0.29	Issue Type +	Ma	Location *	WS
Category	Supplemental			GPS Latitude/Longitude	
				Start	End
Item	USACE Erosion Survey			38.301772 °	38.302358 °
				-121.580093 °	-121.579707 °
DWR ID					
Action/Comments					
Inspector Comments: 2007 - Slow erosion, probably due to wave wash and fluvial erosion. Site has likely been here for awhile but was unseen due to boats parked in front. 2013: No observed changes. [2013 Site ID: STM_25-8_R]

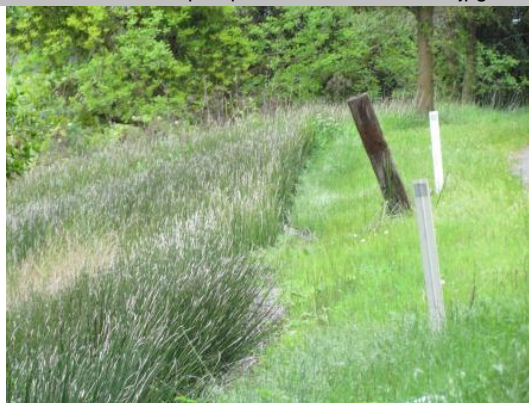
Photo 1 of 1 : phillips\_s\_20140520\_05902.jpg

Unwanted tall reed grasses out of control on the landside slope.

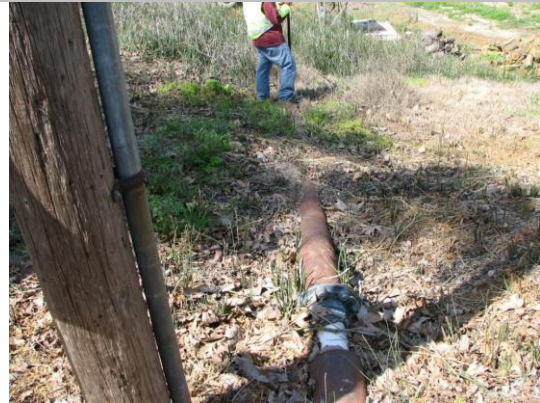
Photo 1 of 1 : UCIP\_2619.jpg

LM Start	0.58	Rating **	M	Issue No.	50
LM End	0.58	Issue Type +	En	Location *	LS
Category	Supplemental			GPS Latitude/Longitude	
				Start	End
Item	DWR UCIP Field Study			38.299353 °	38.299353 °
				-121.581525 °	-121.581525 °
DWR ID	DWR_RD0349_02_s_2014_50				
Action/Comments					
Inspector Comments: FS_ID:21615					
EP_NO: N/A					
Repair Type:					
Crossing Status:					
UCIP Comments: Need to contact owner (Permit No. 3678) to determine if crossing is still in use. If crossing is not in use will need to coordinate with DWR Inspector and CVFPB to remove pipe according to Title 23 requirements. Note date on photos should be 3/18/09 not 7/26/08 camera metadata is incorrect.					
FIELD_STRUCT_DESC: 6-inch irrigation pipe through the levee, 2.5 feet below the crown. Pump on waterward slope. Service pole at landward shoulder. 3-inch conduit through levee to service pump. (USACE-1959). This entry matches the Drainage or Irrigation Structure referenced in O&M manual (HLM 0.6). Pump replaced and placed on concrete pad on waterward slope under Permit No. 3678 (1961). FS Date: 3/18/2009

View of landward side--it appears PVC pipe was sleeved through existing crossing.

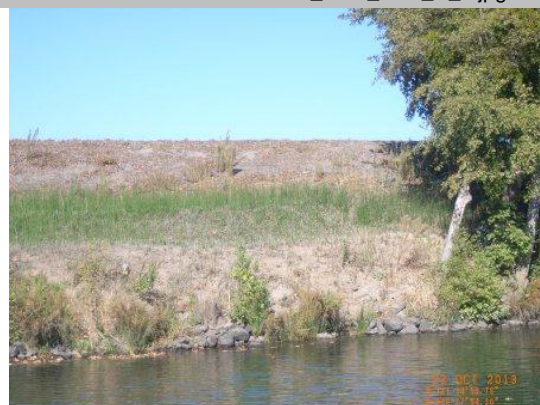
Photo 1 of 1 : USACE2013A\_STM\_25-5\_R\_7.jpg

LM Start	0.60	Rating **	M	Issue No.	27
LM End	0.71	Issue Type +	Ma	Location *	WS
Category	Supplemental			GPS Latitude/Longitude	
				Start	End
Item	USACE Erosion Survey			38.298897 °	38.297384 °
				-121.581571 °	-121.582176 °
DWR ID					
Action/Comments					
Inspector Comments: 2010 - Small maintenance, erosion into the toe. 2011 - Minor new erosion at toe. 2013: No observed changes. [2013 Site ID: STM 25-5 R]

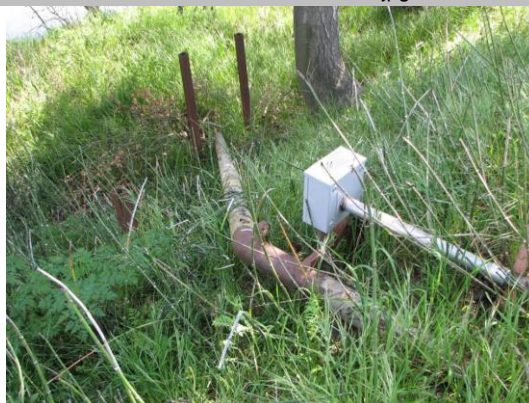
Photo 1 of 1 : UCIP\_2563.jpg

UCIP Comments: Structure appears to be altered (no pump house or siphon breaker present)--need to contact owner. If pipe is no longer used need to coordinate with DWR Inspector and CVFPB to remove per Title 23 requirements. Also dense vegetation limits the inspector's visibility to identify signs of pipe failure (leaks) through the levee slopes. Recommend removing vegetation along pipe alignment to conduct proper inspection of structure and appurtenances. Note date on photos should be 3/18/09 not 7/26/08 camera metadata is incorrect. FIELD\_STRUCT\_DESC: 8-inch steel drainage pipe through the levee, 1.0 foot below the crown. Steel cutoff wall around pipe at center of levee. Siphon breaker and protective housing at levee shoulder. Pump in pumphouse and service pole with anchor at landward toe. (Permit No. 14276-1986)

View of pipe and conduit located on waterward shoulder.

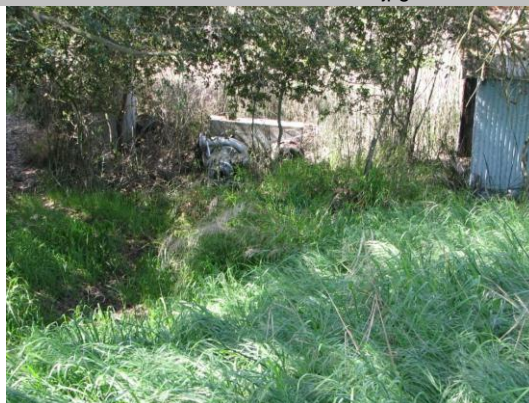
Photo 1 of 1 : UCIP\_2570.jpg

View of landward side--unable to determine structure at the center of photo.

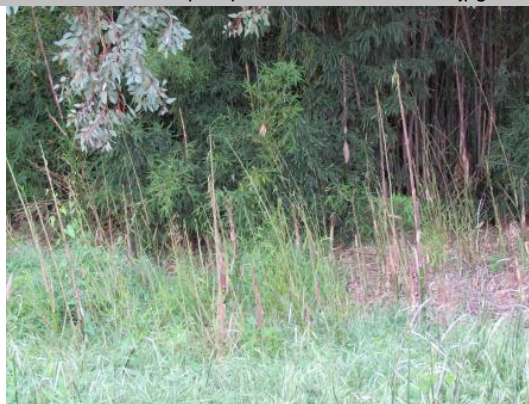
Photo 1 of 1 : phillips\_s\_20140520\_05909.jpg

Wild growth blocking view of the landside levee slope and toe.

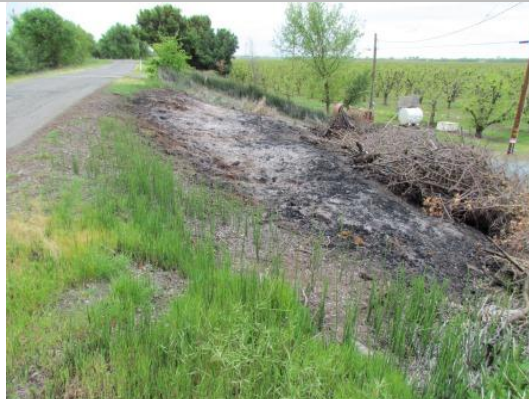
Photo 1 of 2 : phillips\_s\_20140520\_05903.jpg

Here at this burn site the bank has some erosion occurring.

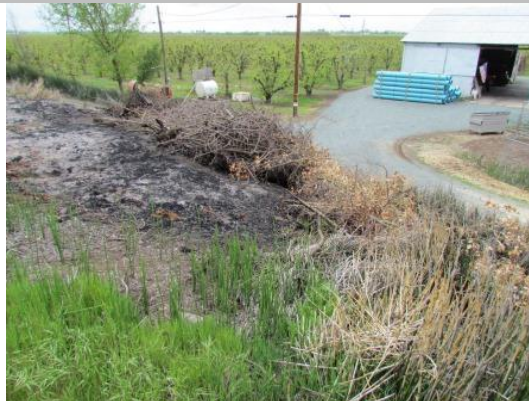
Photo 2 of 2 : phillips\_s\_20140520\_05904.jpg

LM Start	<b>1.00</b>	Rating **	U	Issue No.	<b>79 (cont)</b>
LM End	<b>1.06</b>	Issue Type +	Ma	Location *	LS

Just another view of the erosion along the slope. The erosion was blocked from view by the burn pile.

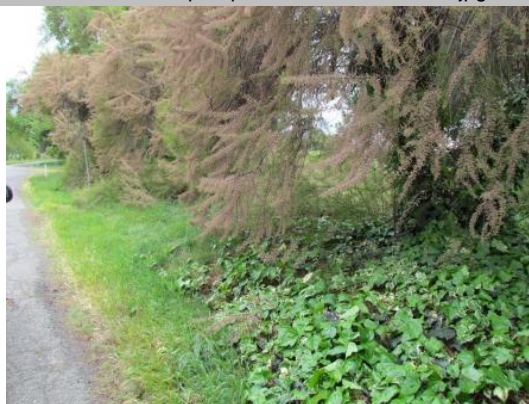
Photo 1 of 1 : phillips\_s\_20140520\_05906.jpg

Woody tree growth blocks view of landside levee section.

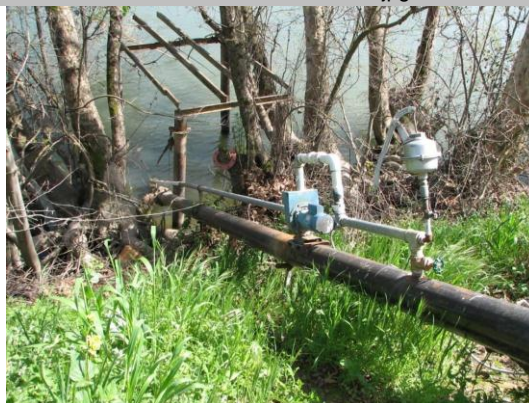
Photo 1 of 1 : UCIP\_2578.jpg

View of abandoned framing located on river's edge.

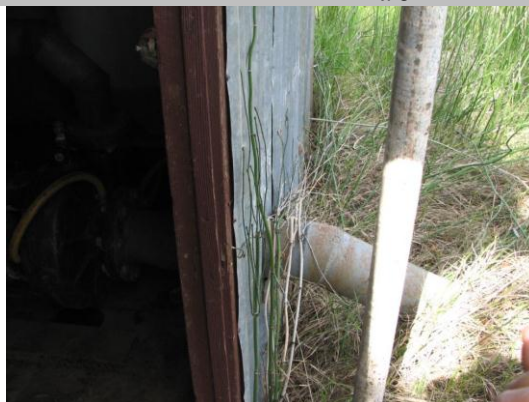
Photo 1 of 1 : UCIP\_2586.jpg

View of pipe daylight at shed on waterward side.

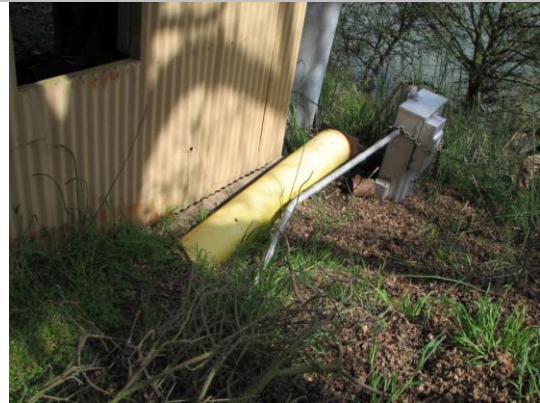
Photo 1 of 1 : UCIP\_2593.jpg

Pipe and conduit daylight next to pump house on waterward side.

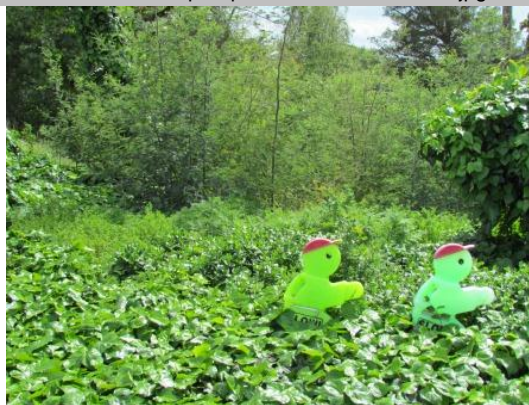
Photo 1 of 1 : phillips\_s\_20140520\_05913.jpg

Woody tree growth and vines completely blocks view of levee section.

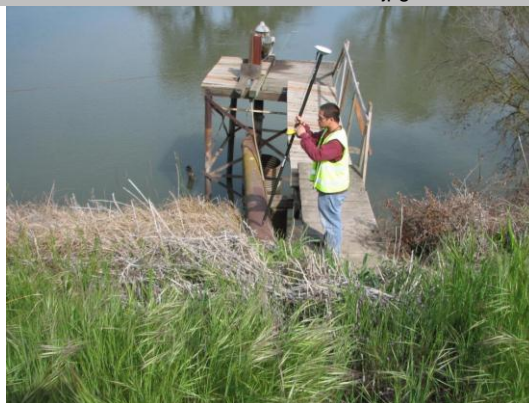
Photo 1 of 1 : UCIP\_2599.jpg

Overview of waterward side--dense vegetation limits slope inspection.

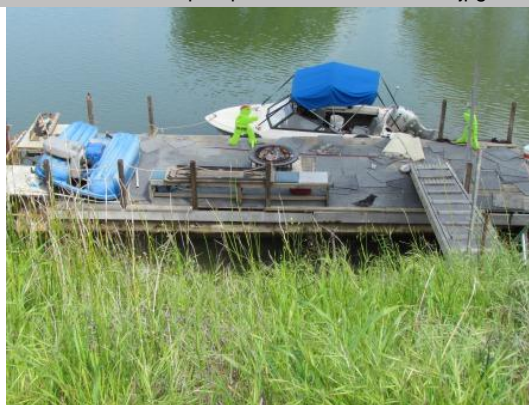
Photo 2 of 2 : phillips\_s\_20140520\_05915.jpg

Unauthorized boat dock at end of steps.

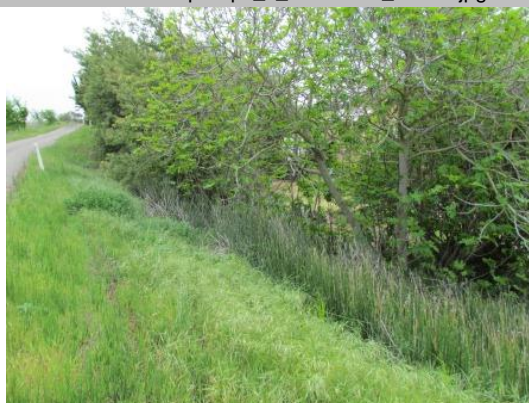
Photo 1 of 1 : phillips\_s\_20140520\_05916.jpg

Woody tree growth blocking view of landward levee section.

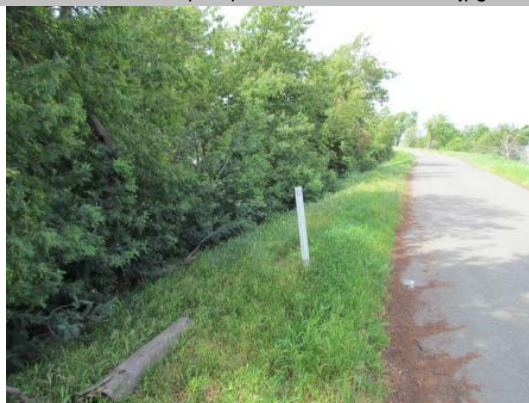
Photo 1 of 1 : phillips\_s\_20140521\_05919.jpg

Woody tree growth completely blocking view of landward levee slope.

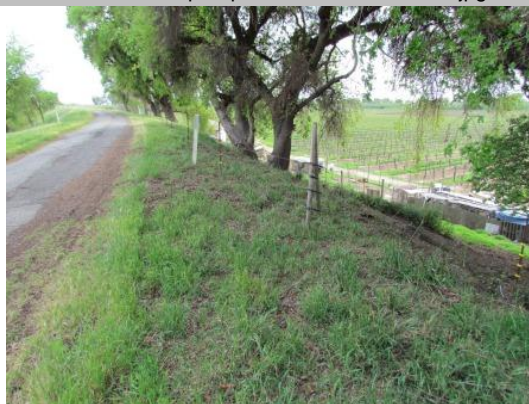
Photo 1 of 1 : phillips\_s\_20140521\_05917.jpg

Unpermitted fence on landside shoulder and slope of levee section.

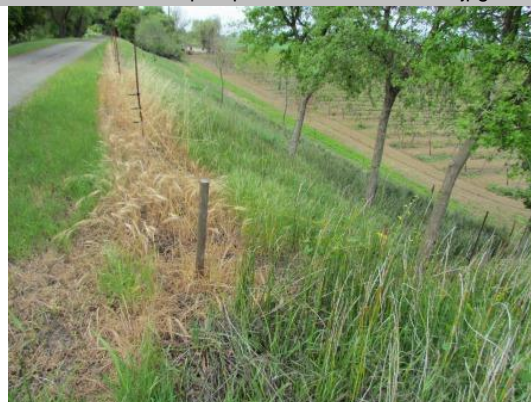
Photo 1 of 2 : phillips\_s\_20140521\_05923.jpg

Unauthorized electric wire fence on landside shoulder.

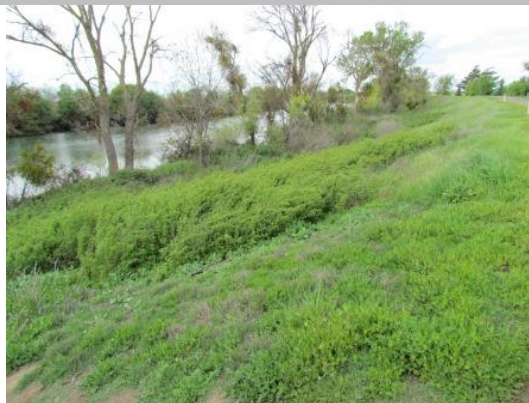
Photo 1 of 1 : phillips\_s\_20140521\_05927.jpg

Wild growth of tall grasses on the waterside levee slope.

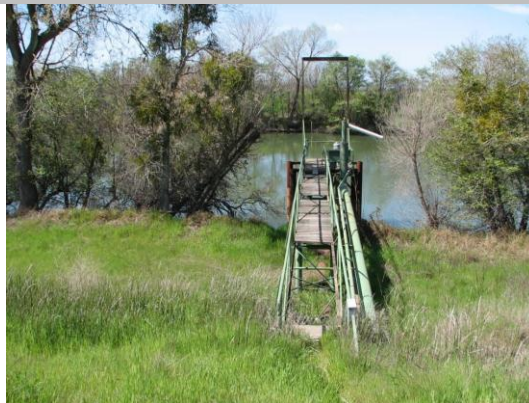
Photo 1 of 1 : UCIP\_2652.jpg

View of waterward side--pipe, conduit, pump, and damage walkway.

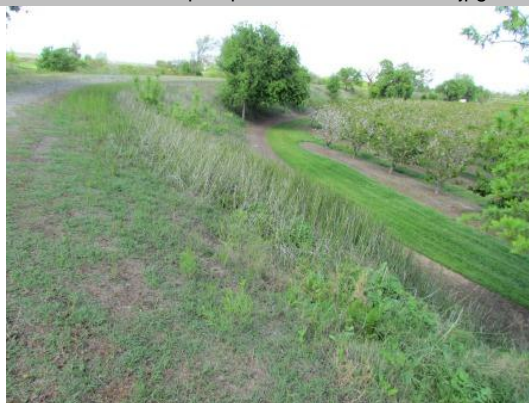
Photo 1 of 1 : phillips\_s\_20140521\_05935.jpg

Tall weeds on landside slope 2 1/2-3-foot tall.

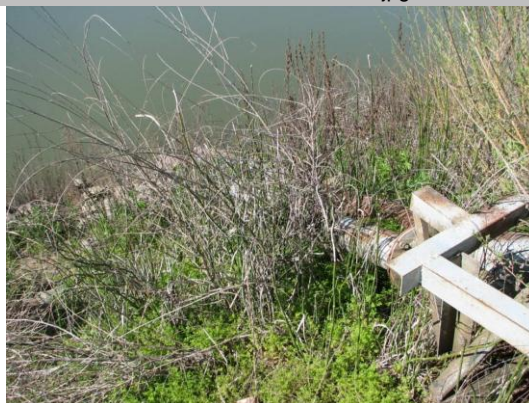
Photo 1 of 1 : UCIP\_2688.jpg

Waterward side--pipe visible through dense vegetation.

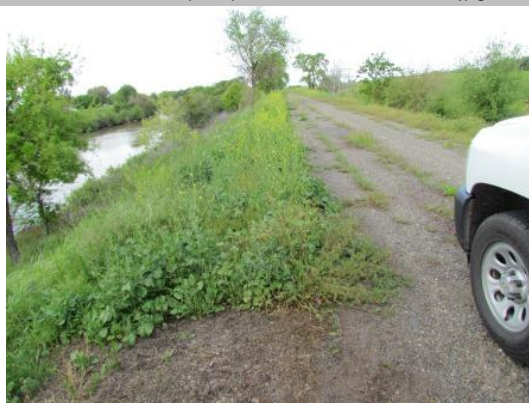
Photo 1 of 1 : phillips\_s\_20140521\_05934.jpg

Tall weeds on waterside shoulder and slope.

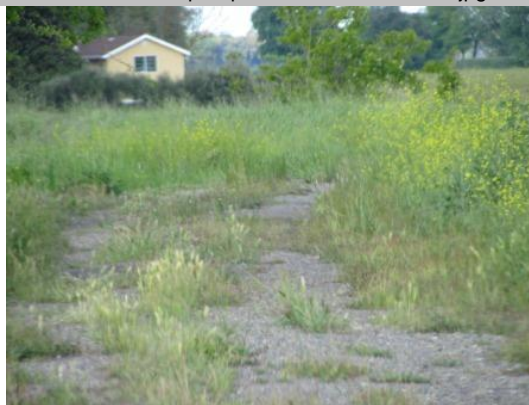
Photo 1 of 1 : phillips\_s\_20140521\_05930.jpg

Tall weeds has completely taken over crown roadway.
